Inspection Report
Minerals Regulatory Program
Date: 06/24/2009

Mine Name: Energy Queen	Permit Number: M0370043
Operator Name: Energy Fuels Resources Corp	Inspection Date: 04/06/2009
Inspector(s): Tom Munson	Time: 2:00 pm
Other Participants:	Mine Status: Active

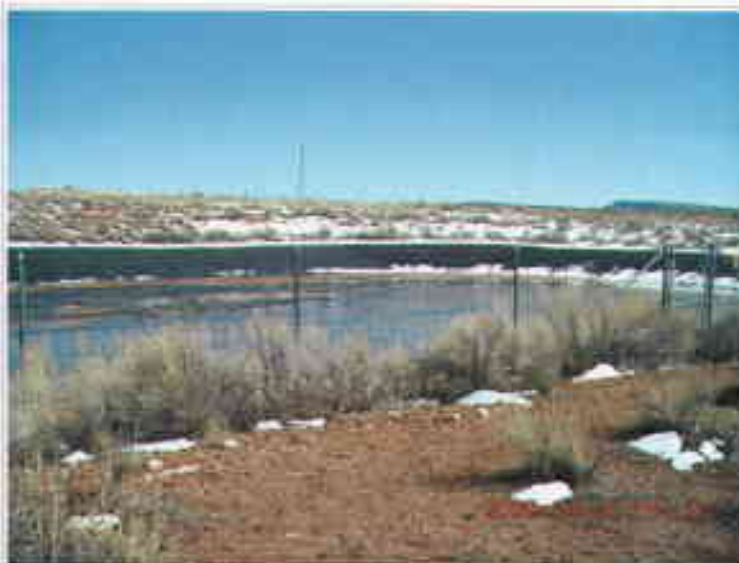
Water treatment pond. material in bottom of pond is contaminated

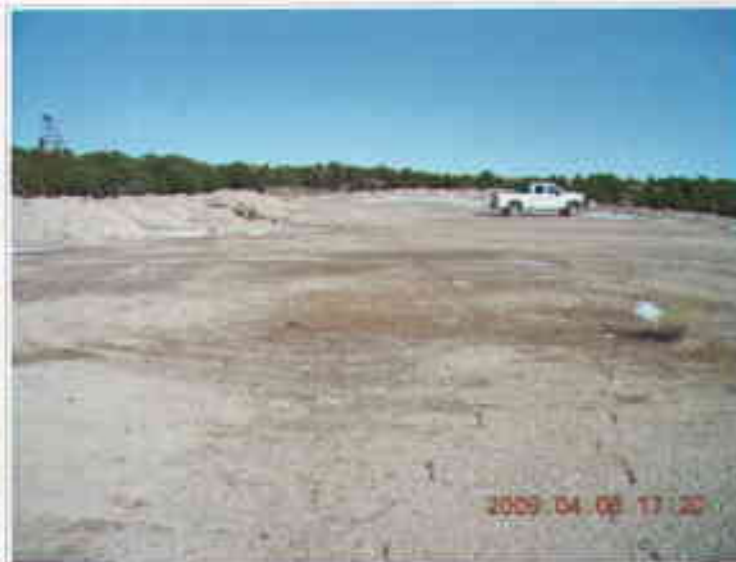
Waste rock pile

The issue of waste rock contamination was discussed and was left to a later date.

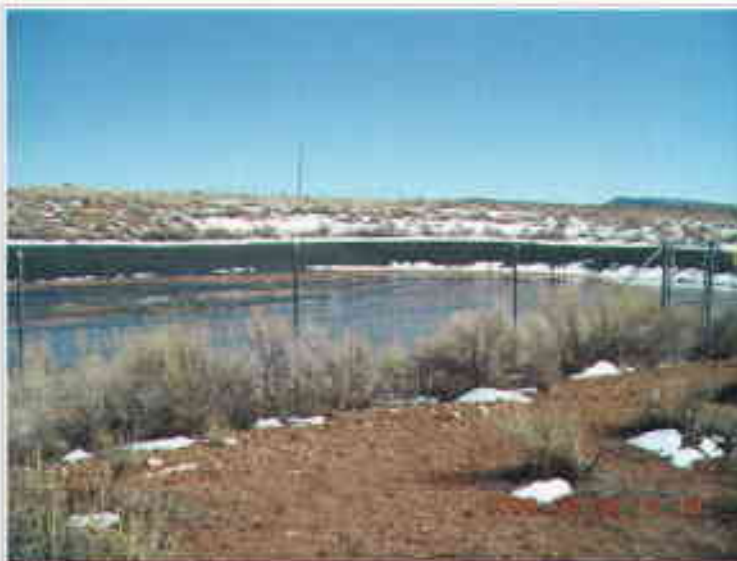
Water treatment pond, material in bottom of pond is contaminated
